# Milling About

News from the Friends of Peirce Mill Spring/Summer 2002

## Repairs to the Main Beam and Column

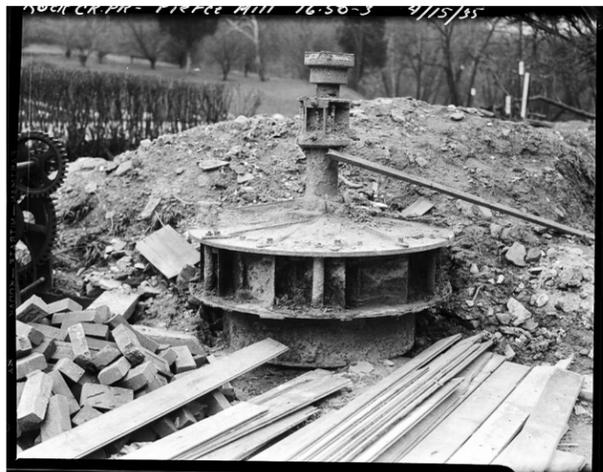
This photo from April 1935 shows the turbine lying horizontally and half-buried in construction debris. In the 1935 restoration, supervised by noted architect Thomas T. Waterman, the millwrights used a breast wheel design, a different solution to the problem of low head.

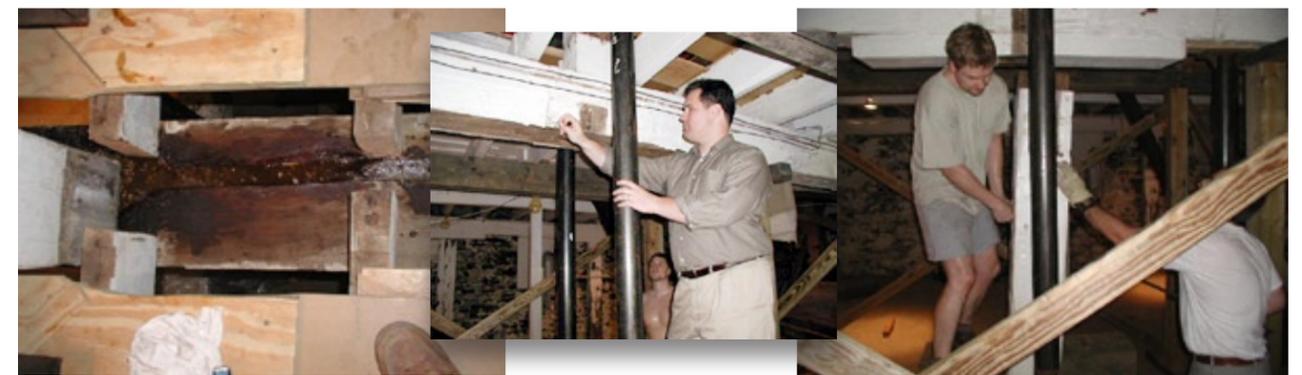
Images of recent work on the support beams at the Mill. Left: Completed work on the main beam showing steel rods set in epoxy. Engineer **Brandon Rossetti** (center) inspecting the beam after column removal. At right, **Steve Ortado** and assistant **John Waters** removing the old column supporting the main beam.

Our contractor, **Steve Ortado**, has completed repairs to the main beam and the column which rests on it and supports the upper floors. The first part of this delicate work involved placing stainless steel rods in the crack in the top of the beam, then filling the area around it with a special type of epoxy material, greatly adding to the strength of the beam. Then a welded steel plate was placed between the beam and the column above it to provide a firm base for the column. Finally, another type of epoxy was injected into the base of the upper column to fill the voids left after removal of rotten wood.

Another part of the job involved removal and inspection of the column supporting the main beam at

the basement level. After installing a system of heavy shoring beams, Steve was able to remove the column and the capital above it. Inspection of the column revealed damage at the upper end where it was inserted into the capital. Because the column had already had its lower end removed some years ago due to water damage and replaced by wooden blocks, our structural engineers have recommended that it be replaced with an entirely new column which will rest on the stone foundation as it originally did. It is proposed also to install a new capital equal in size to those in the floor above, rather than the undersized one just removed. These recommendations have been submitted to Rock Creek Park and a decision is awaited.
